Fall 2004

Cathey's Creek Newsletter

Watershed Assessment Results

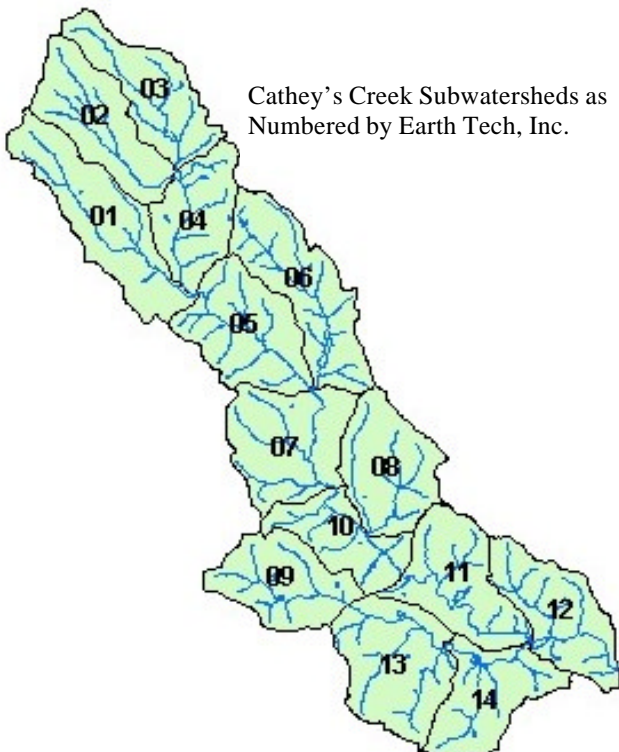
GIS Update Results (from 1992-1998)

⇒ A decrease in forest cover was found in subwatersheds: 01,02,09,11,13,14 (see diagram 1).
