# Fishing Creek Local Watershed Plan Water Quality Study

Presented by NC Division of Water Quality  
Watershed Assessment Team  
Fishing Creek Stakeholders' Meeting  
July 31, 2007

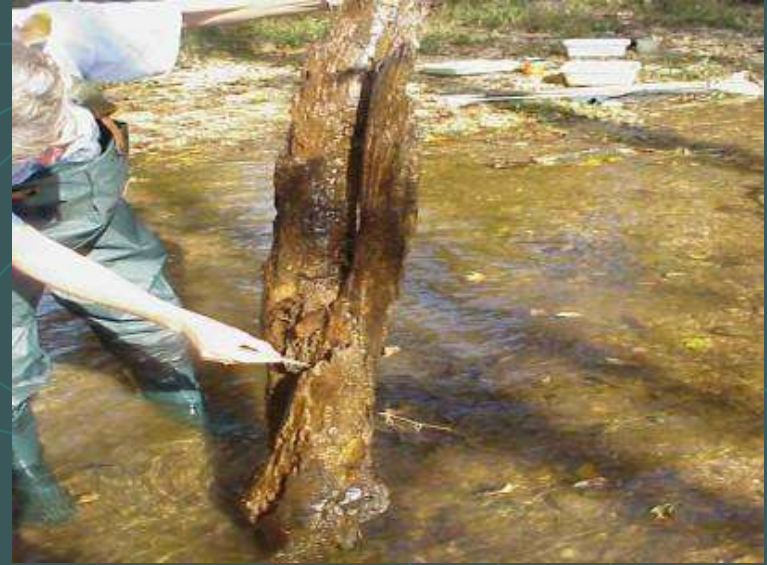
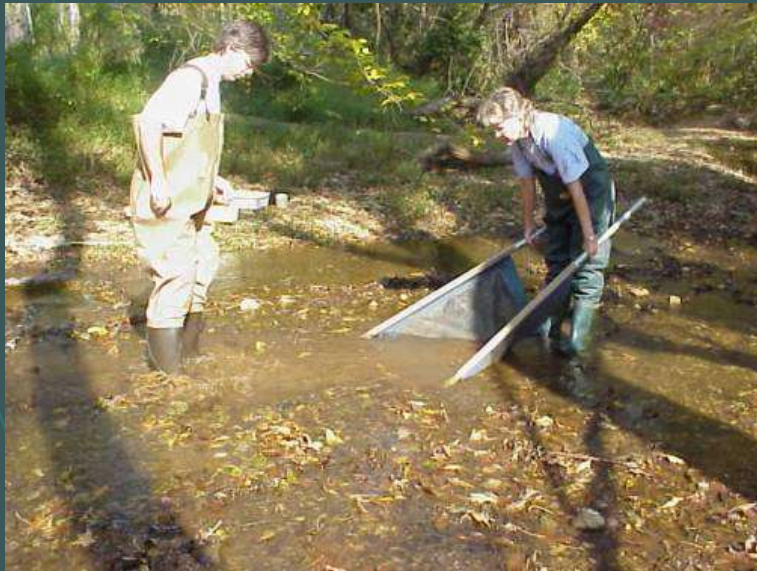
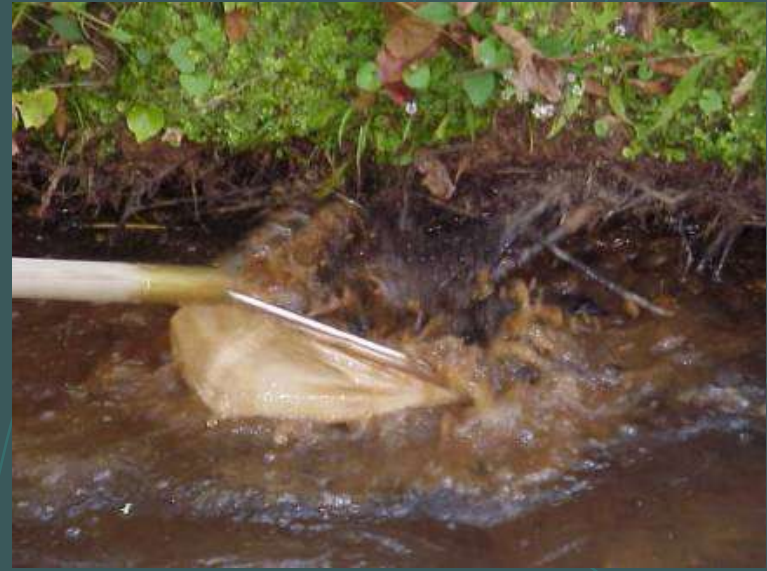
# Benthic macroinvertebrate Sampling methods

- DWQ Biological Assessment Unit (BAU) SOPs  
[h2o.enr.state.nc.us/esb/BAU.html](http://h2o.enr.state.nc.us/esb/BAU.html)

- Bugs ID'ed to lowest possible taxonomic level
- Abundance and sensitivity of individual taxa used to calculate Biotic Index (BI), scale of 0-10
- The lower the BI, the healthier the bug community
- BI can be used to assign a “bioclassification” to waterbody (e.g., Excellent, Good, Good-Fair, Fair, Poor)
- Community composition can also provide evidence for nutrient enrichment, toxicity, flow issues, etc.

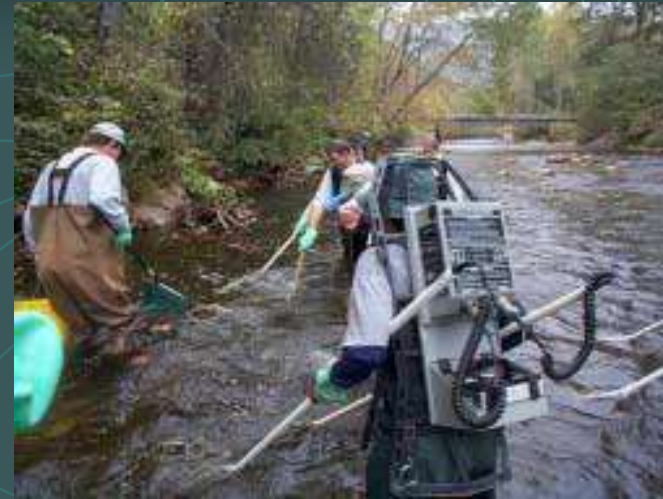
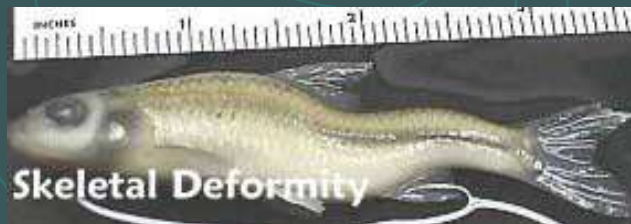
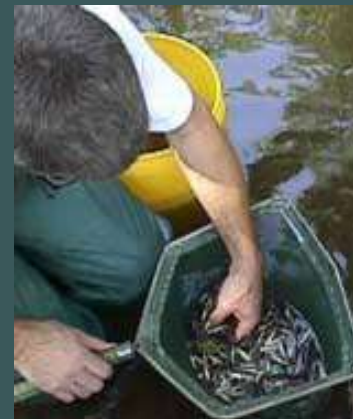
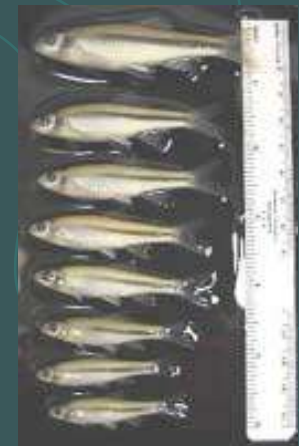
# Fish community Sampling methods

- Assesses streams' biological integrity, based on species richness/composition, indicator species, trophic function, abundance and condition, reproductive function
- Electrofishing using backpack shockers
- In this study species list may be useful to mussel folks for determining presence of host species
- Sampled at 5 locations in LWP area

- DWQ Biological Assessment Unit (BAU) SOPs  
[h2o.enr.state.nc.us/esb/BAU.html](http://h2o.enr.state.nc.us/esb/BAU.html)

- Calculate NC Index of Biological Integrity (NCIBI)
- Scale of 0-60
- The higher the NCIBI, the healthier the community
- NCIBI can be used to assign a “bioclassification” to waterbody (e.g., Excellent, Good, Good-Fair, Fair, Poor)

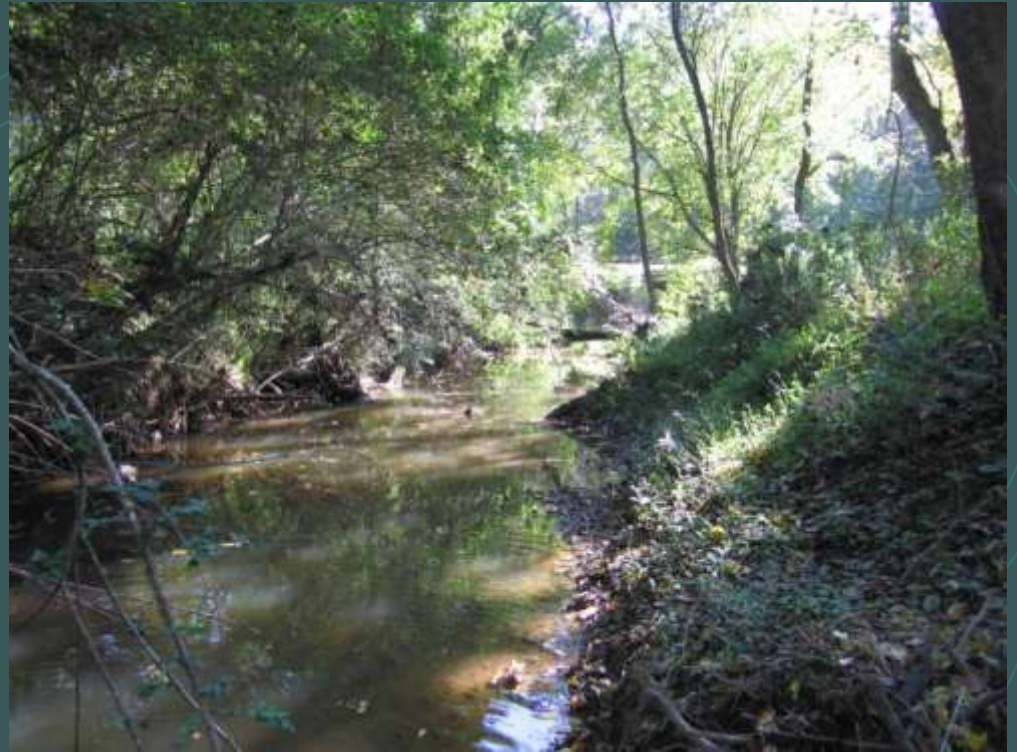
# Jordan Cr. at Salem Rd. (SR 1522)

- Very high metals (Pb, Cu, Zn, Fe, Al, Mn), nutrients (NH<sub>3</sub>, TKN), residue, and turbidity results from storm sample
- Will continue limited follow-up sampling

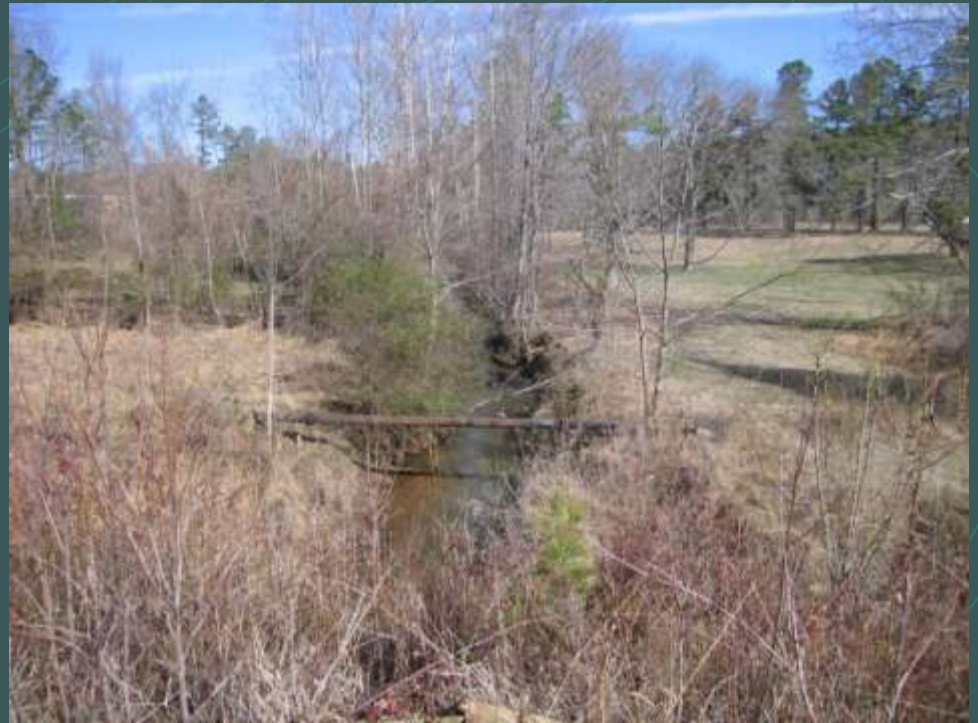
# UT to Jordan Cr. at US 158 bypass

- Flow often low (like most sites in study), moderate habitat score
- Located next to Webb HS, may be a good place for a demonstration enhancement project?

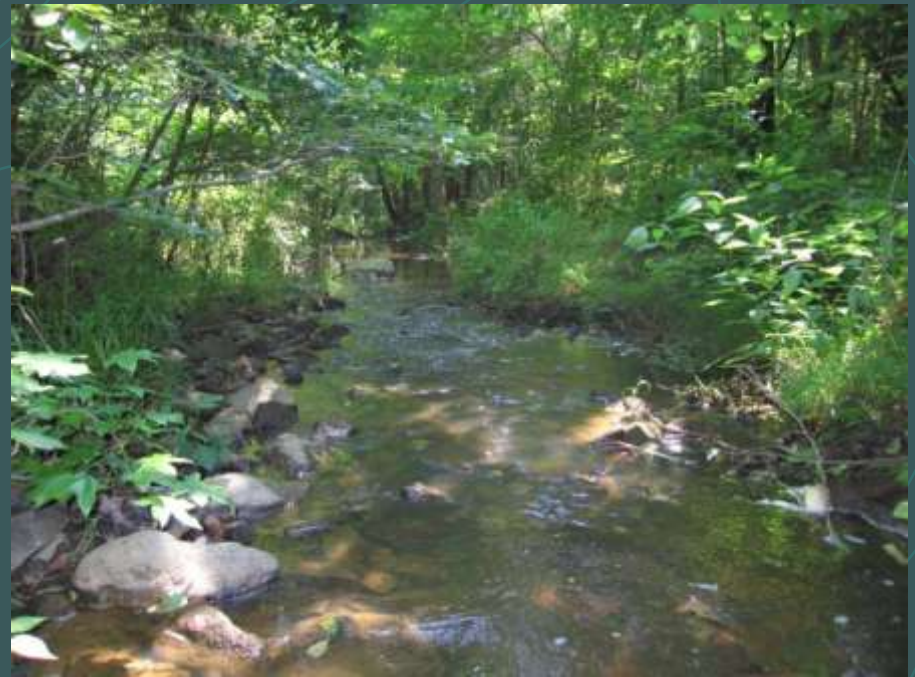
# Coon Cr. at Perry Rd.

- Intended as a “reference” site
- Very high nutrients
- Sporadic elevated conductivity (max=319)
- Odd surface foam (positive for detergents) & discolored water
- Grey water? Agriculture?
- May be good catchment for agriculture BMPs?

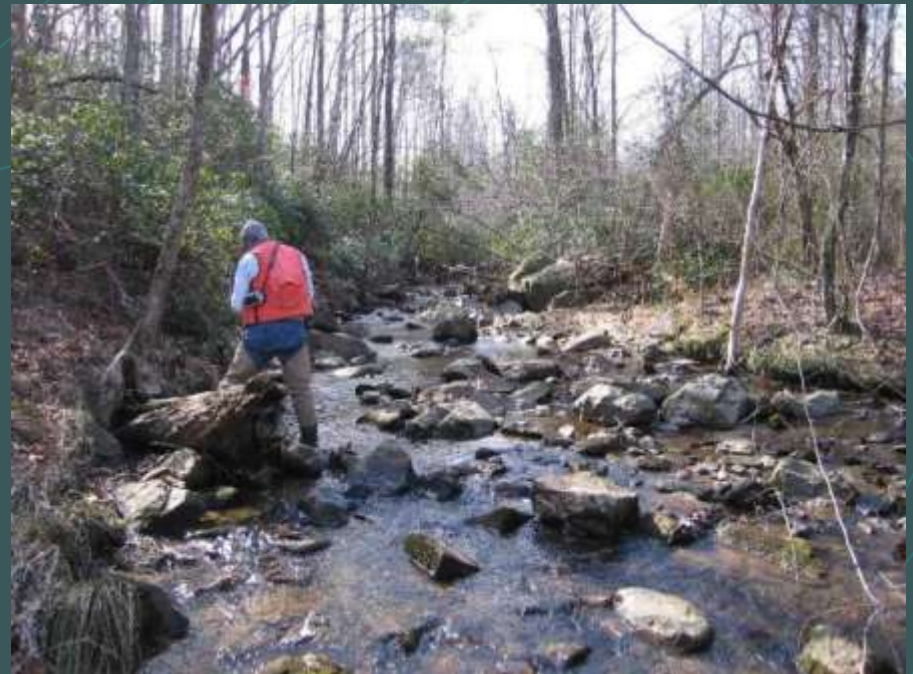
# Sand Cr.

- Unusual “looking” stream for piedmont and for LWP area
- Some siltation/ sedimentation
- Benthos community excellent overall, though fewer than expected EPT taxa
- Bug data suggest poor flow during part of year, but site had most consistent flow in study
- Slate Belt or Triassic Basin?

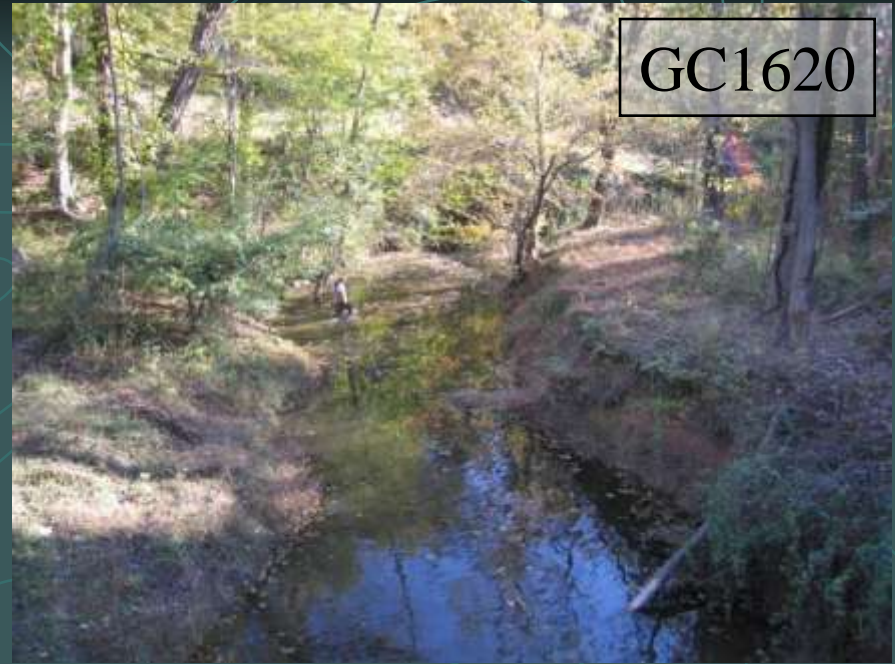
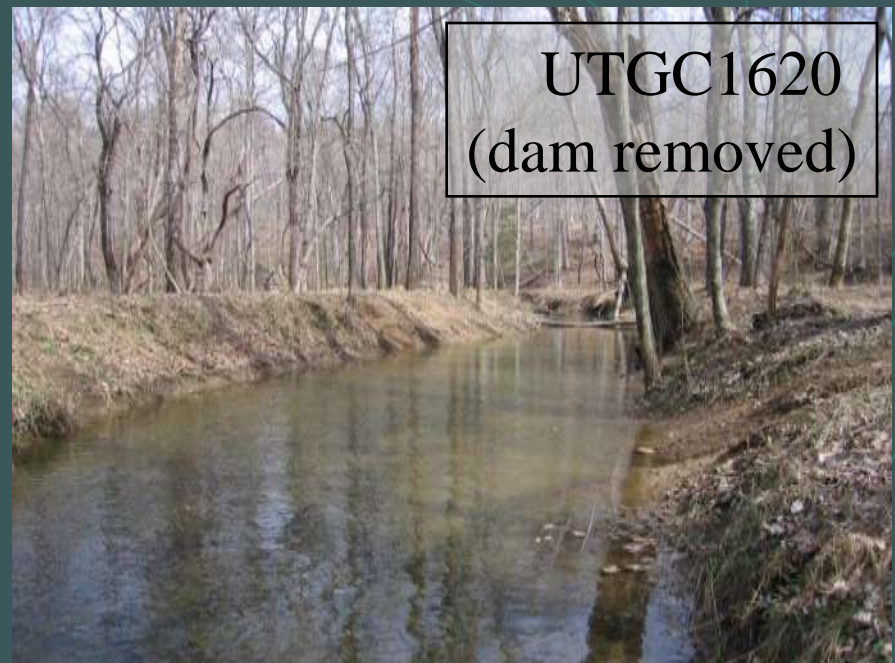
# Gibbs Cr. and UT to Gibbs Cr.

- Undeveloped area
- Good benthos,  
Excellent fish, few  
chemistry problems
- Moderately low habitat  
scores
- Poor flow
- Very sandy substrate,  
filling in, incised banks
- Poor quality understory

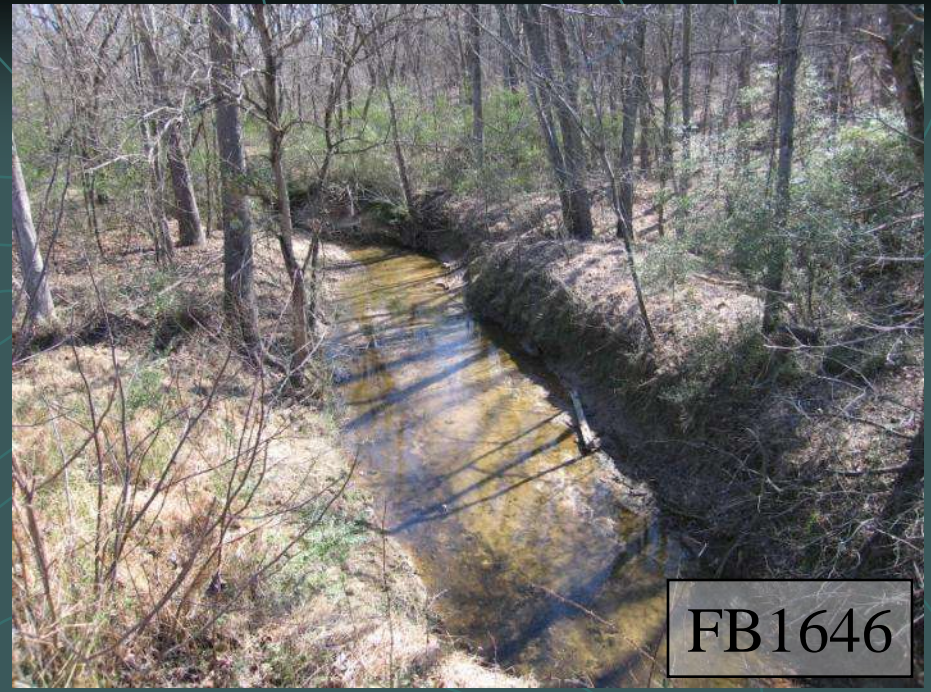
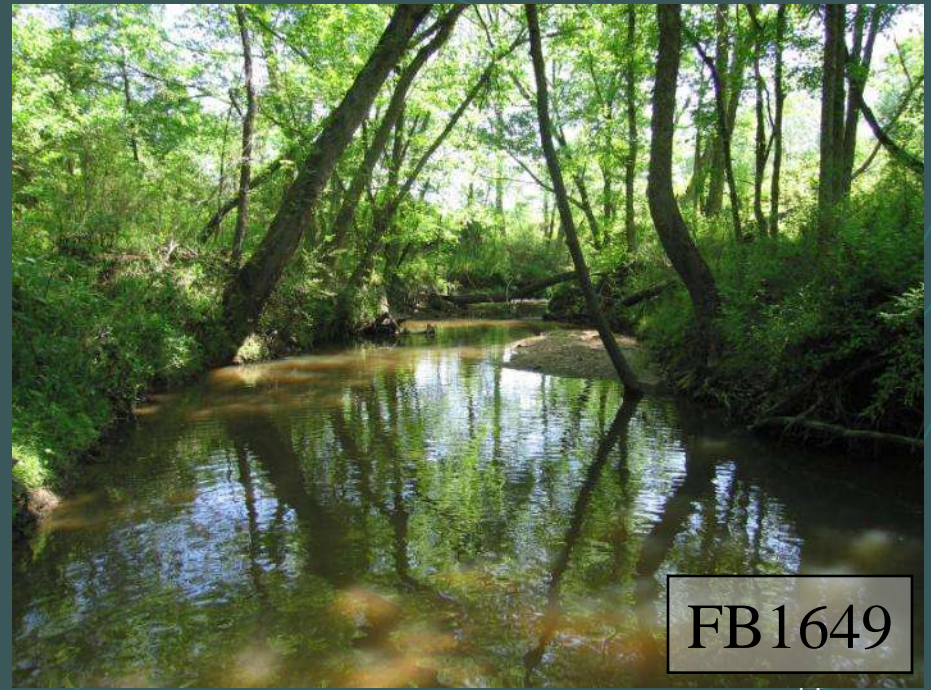
# Foundry Br.

- Two sites, practically identical results
- Typical urban issues- bacteria, conductance, TSS, turbidity, nutrients, Cu, Zn
- Poor habitat
- Flashy
- Subwatershed may benefit from stormwater BMPs?

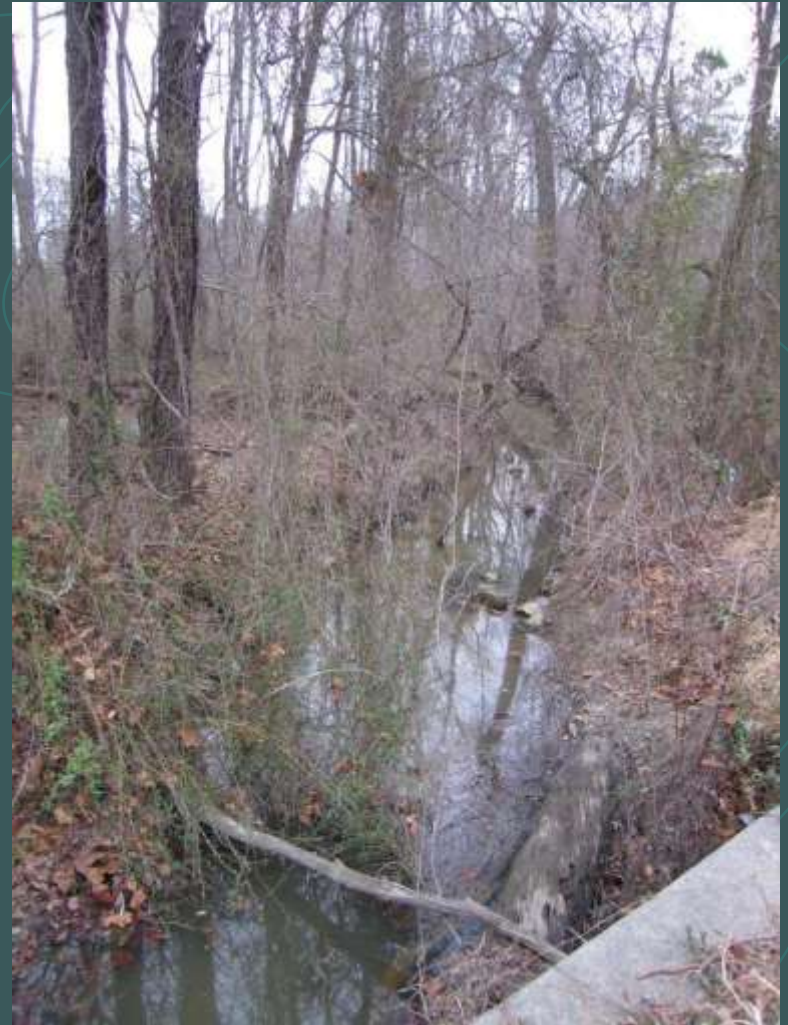
# Fishing Creek at US 15

- Very poor habitat
- Very poor flow
- Exotics in riparian zone
- Beaver activity
- May benefit from restoration or enhancement?

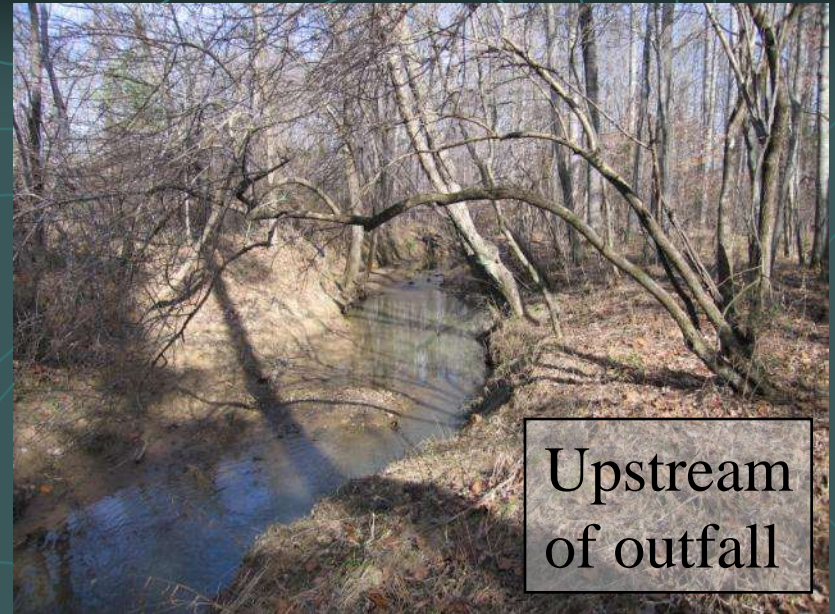
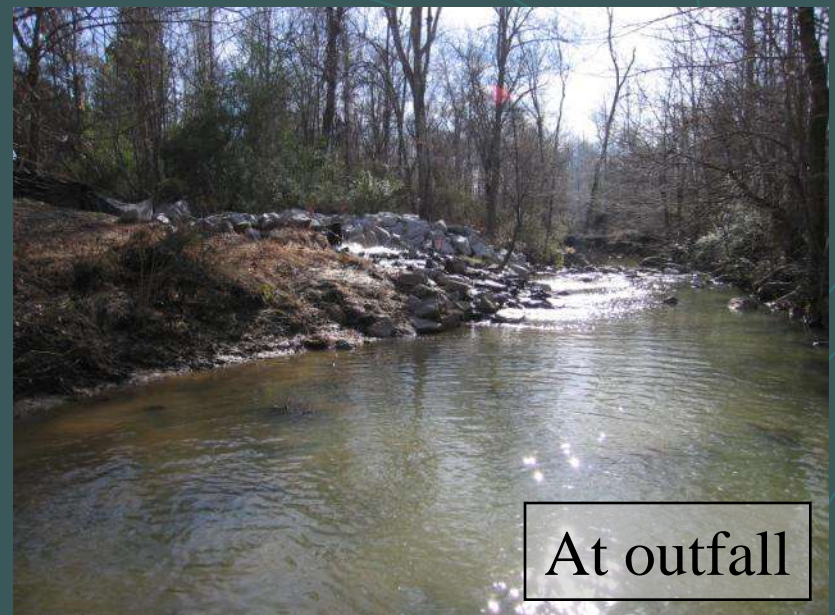
# Fishing Creek near outfall

- Improvements as compared to US 15
- Impacts from upstream land use fewer than expected, though still issues
- More significant impacts due to inputs from Foundry Br. and point source
- Extreme elevation of many parameters

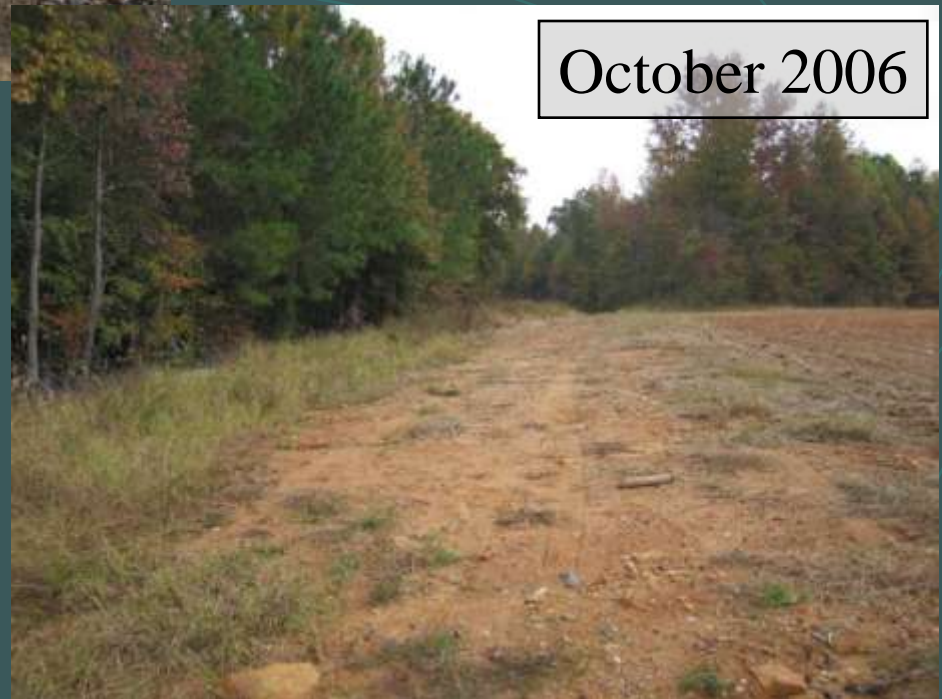
October 2006

Non-vegetated easement allows sediment inputs from easement and adjoining ag field

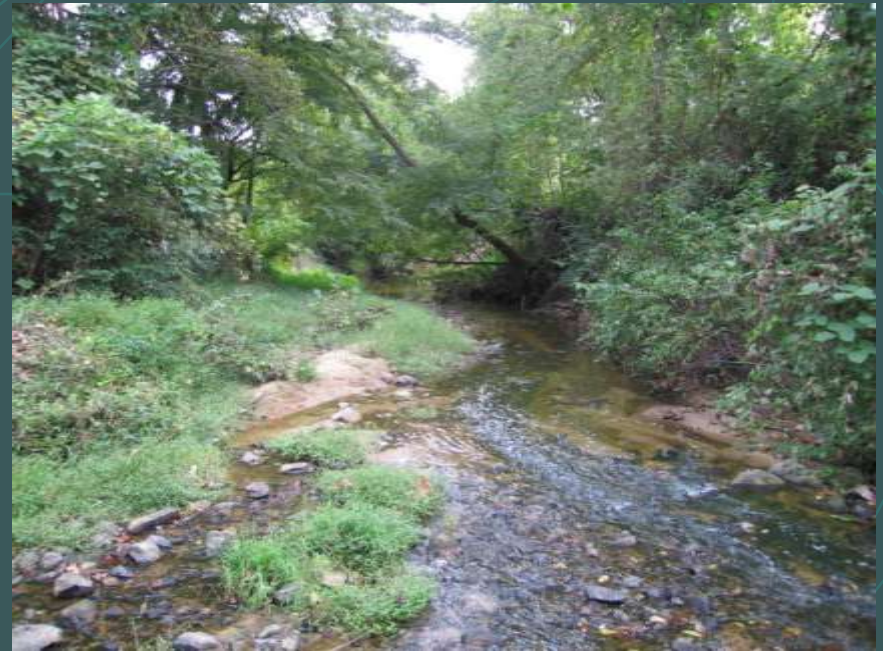
# Fishing Cr. at Fielding-Knotts Rd. (SR 1608)

- Habitat improved as compared to upstream
- Benthos community stressed, lowest BI in study
- Community shows indicators of toxicity and nutrient enrichment
- Conductivity too high for fish sampling

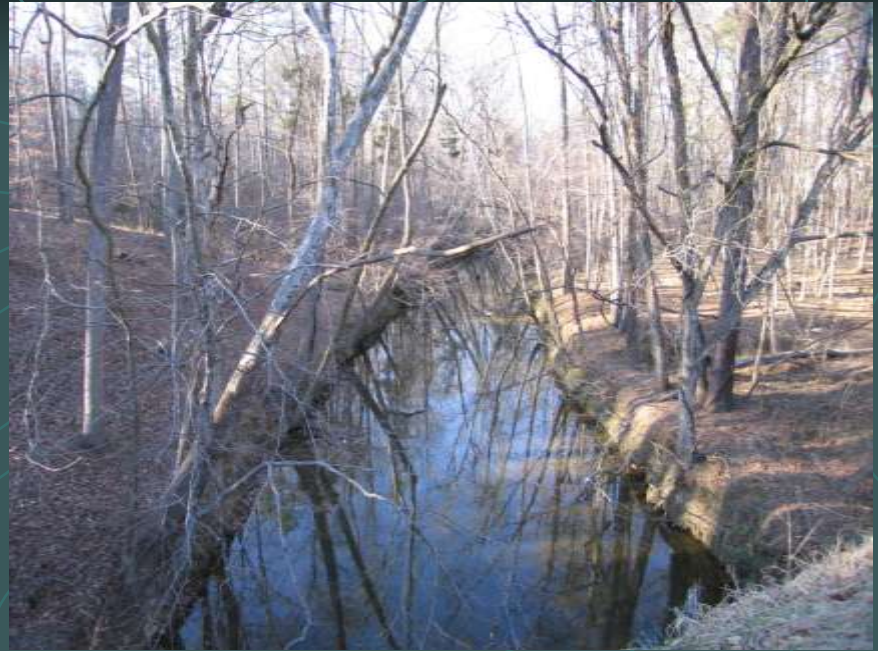
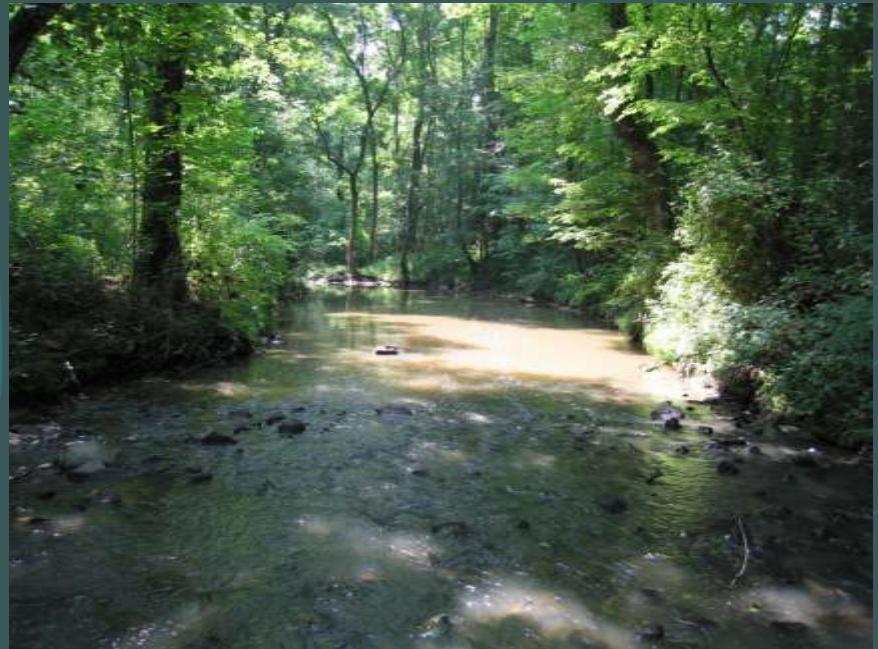
# Fishing Cr. at NC 96

- Severe overgrowths of algae in early spring; pH WQ standard exceedence (9.1 su)
- Coliform consistently high
- Additional nutrient and coliform inputs just upstream- source?
