## The Site Atlas: A catalogue of potential restoration projects

# Hendricks Creek Watershed Plan Summary

The Ecosystem Enhancement Program (EEP), a non-regulatory program within the NC Department of Environment and Natural Resources, sponsored a local watershed planning project in four watersheds in the middle Tar-Pamlico River Basin. These watersheds drain to Green Mill Run, Cow Swamp, Crisp Creek, and Hendricks Creek. The Watershed plans were completed in 2005.

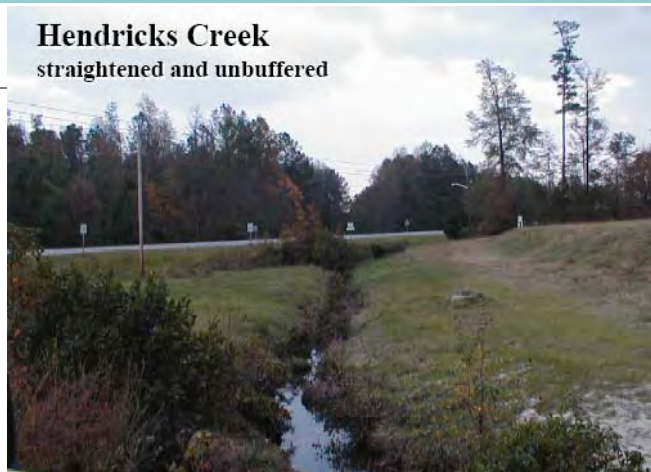
**Hendricks Creek**  
straightened and unbuffered
