Cathey's Creek Critical Area Report Summary for the Technical Advisory Committee

February 7, 2005

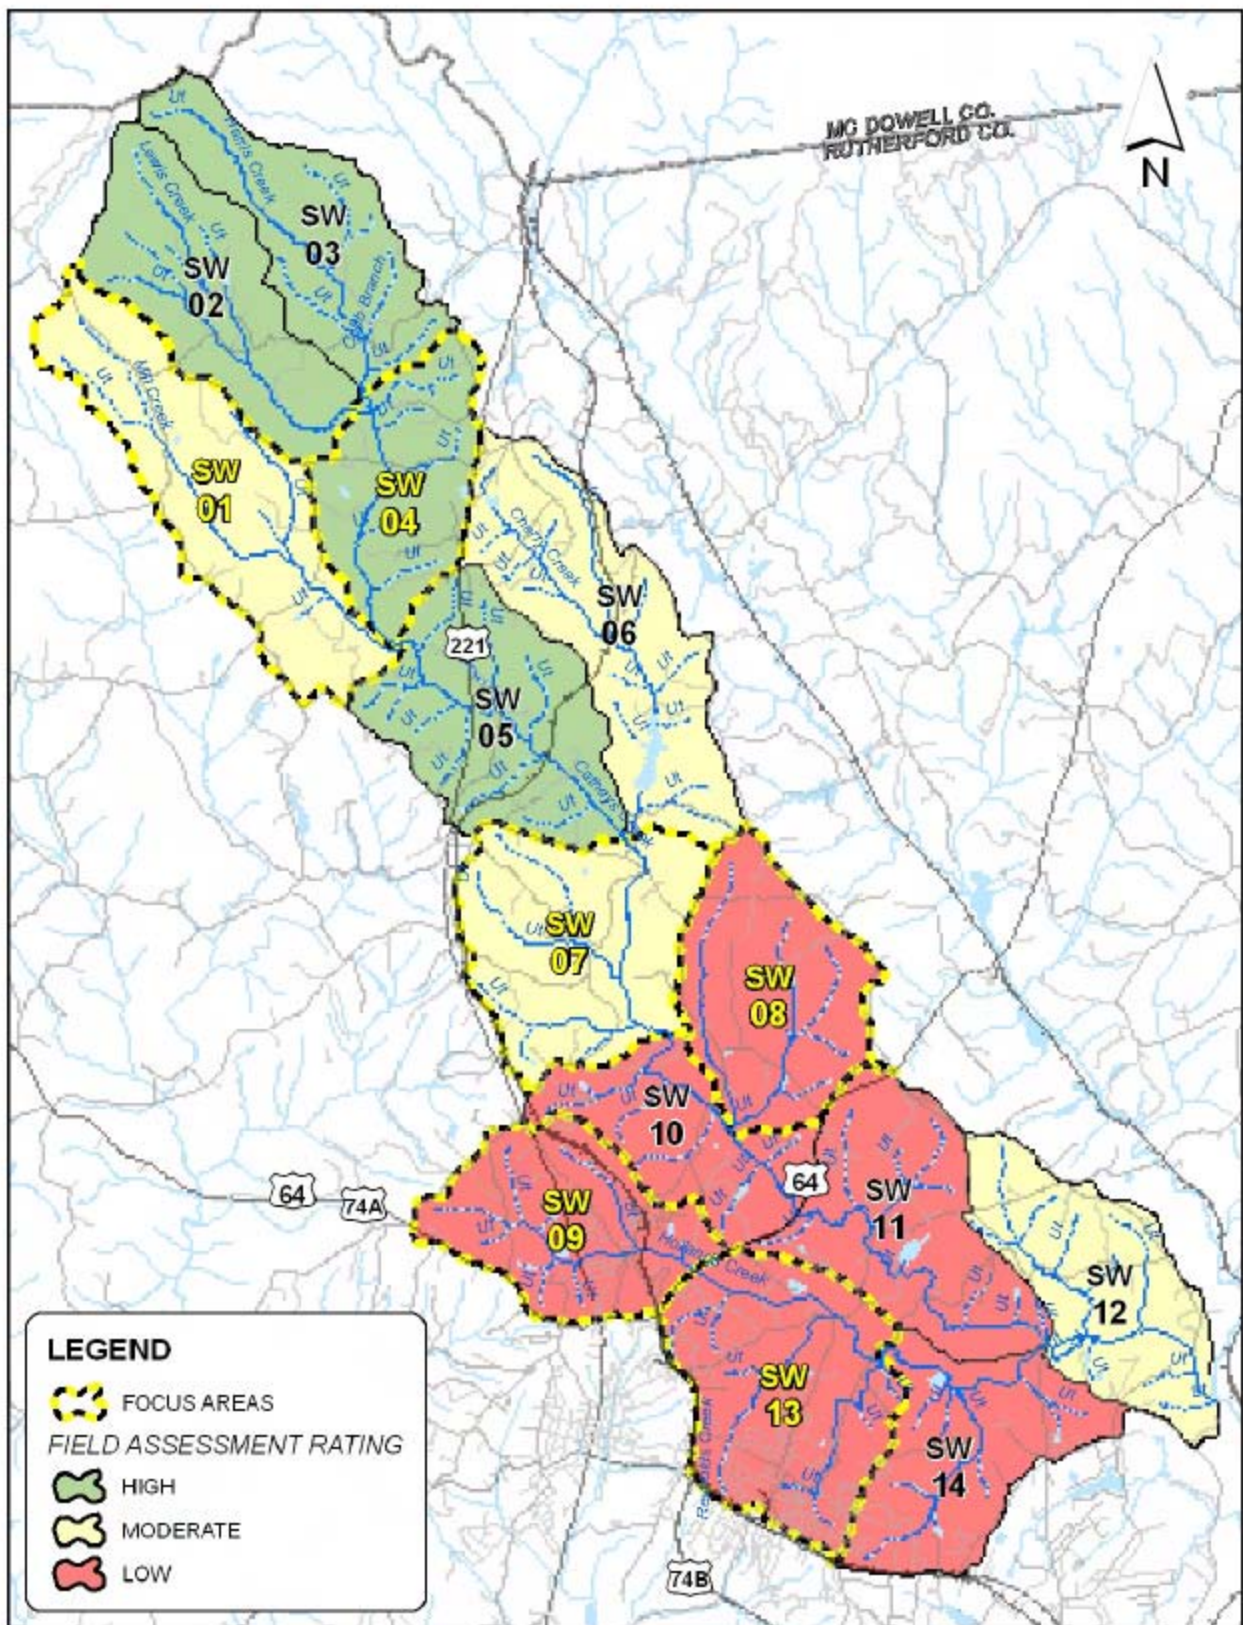
Figure 2: Cathey's Creek Watershed with subwatersheds shaded according to field assessment results, and with potential focus areas recommended by Earth Tech highlighted

When a subwatershed held the same ranking following the field assessment, evidence is strong that the ranking is accurate (these SWs are highlighted in bold). Figure 2 on page 10 illustrates the subwatersheds shaded according to their rankings, with recommended focus areas highlighted.
